**FINAL
OFF-SITE AREA INTERIM ENGINEERED COVER
CONSTRUCTION COMPLETION REPORT
Including Spoils Pile Consolidation**

**AMERICAN CHEMICAL SERVICE, INC.
NPL SITE
GRIFFITH, INDIANA**

MWH File No. 2090601

February 2003

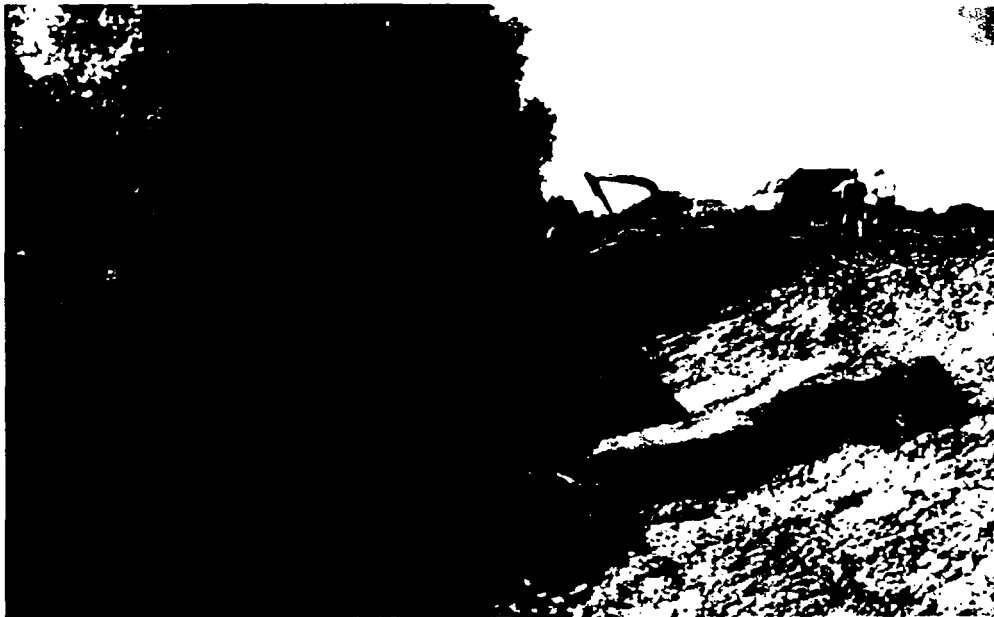
6. August 2001 (Looking South): Straw bales are used to reduce erosion on the site as part of the Stormwater Pollution Prevention Plan.

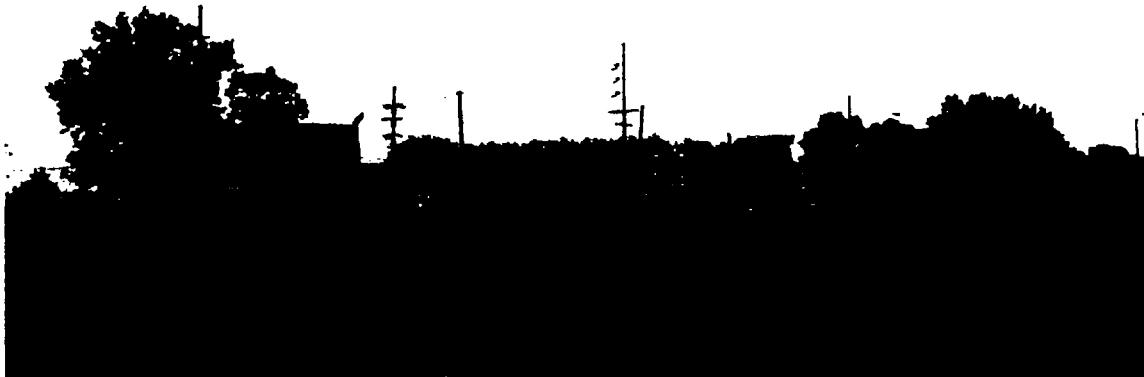
9. July 2001 (Looking South): A tractor pulls a sheepfoot roller (left) to compact the imported clay.

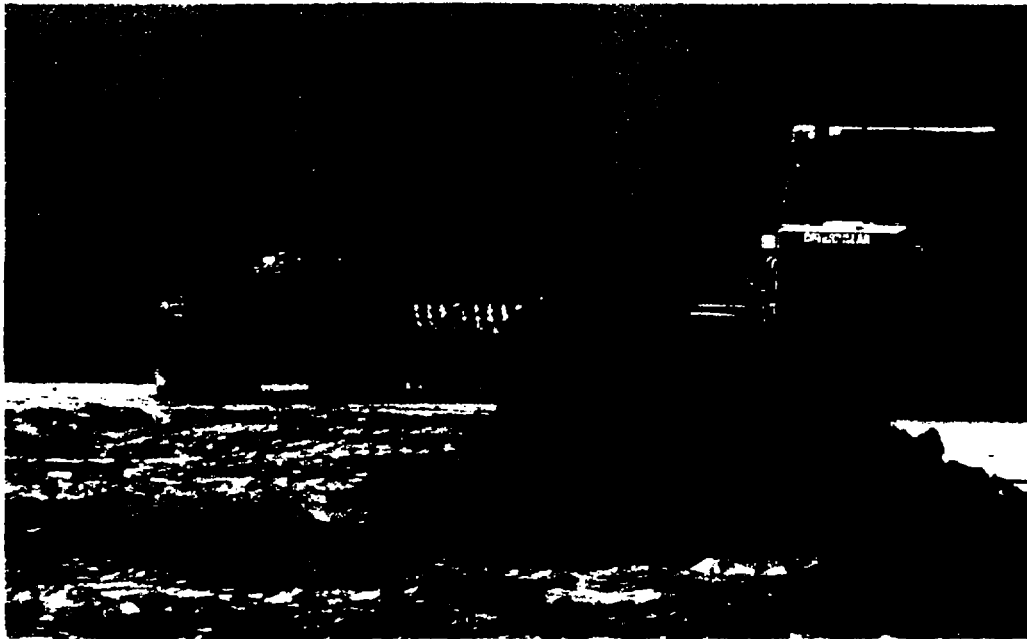
10. July 2001 (Looking West): A bulldozer (right) spreads imported clay across the Off-Site Area in six inch thick lifts.

The imported clay was visually inspected and found to be free of grass, roots, brush, other organic material, debris, and refuse and therefore deemed suitable for cover material. The clay was installed in six-inch lifts as specified by MWH.

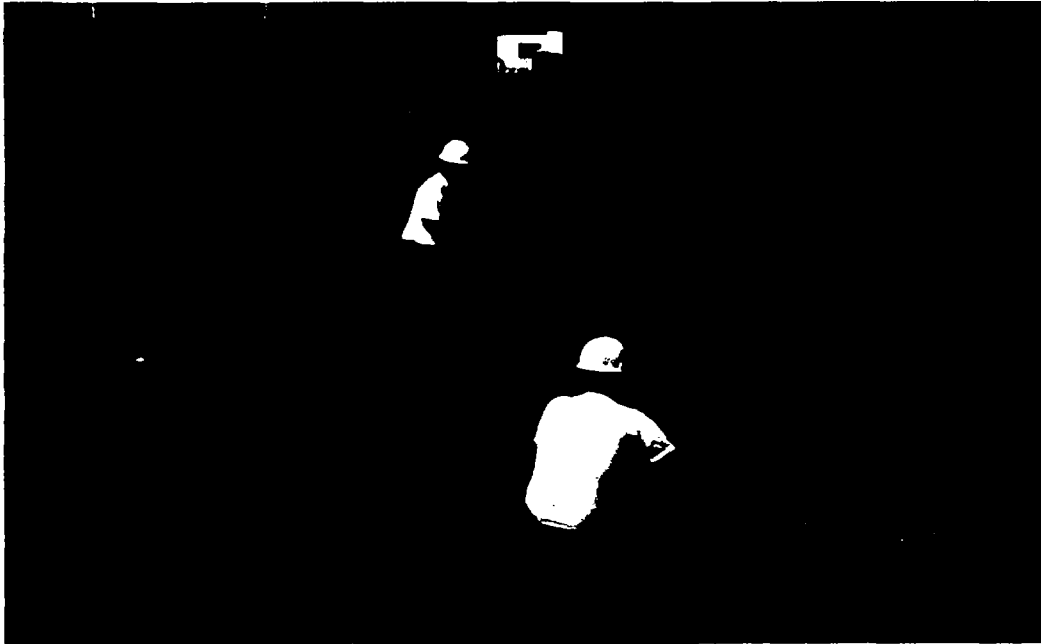
13. August 2001 (Looking Southwest): Geotextile fabric is spread across swale 1 prior to the placement of rip rap.

The three exterior swales, Swale 1, Swale 3, and the eastern portion of Swale 4, were covered with rip rap. They were first lined with Mirafi 1160N geotextile fabric. The fabric is a non-woven geotextile fabric composed of polypropylene fibers. It is inert to biological degradation and resists naturally encountered chemicals, alkalis, and acids. The fabric possesses a weight of 14.5 oz/yd², a puncture strength of 235 lbs., and a grab tensile strength of 380 lbs. After placement of the Mirafi 1160N, the three exterior swales were lined with approximately 2,700 square yards of rip rap (see Figure 10 and detail A of Figure 11). The limestone rip rap, imported from Crown Point, Indiana, was uniformly graded between 3 and 8 inches in diameter, with approximately 50% between 4 and 6 inches.

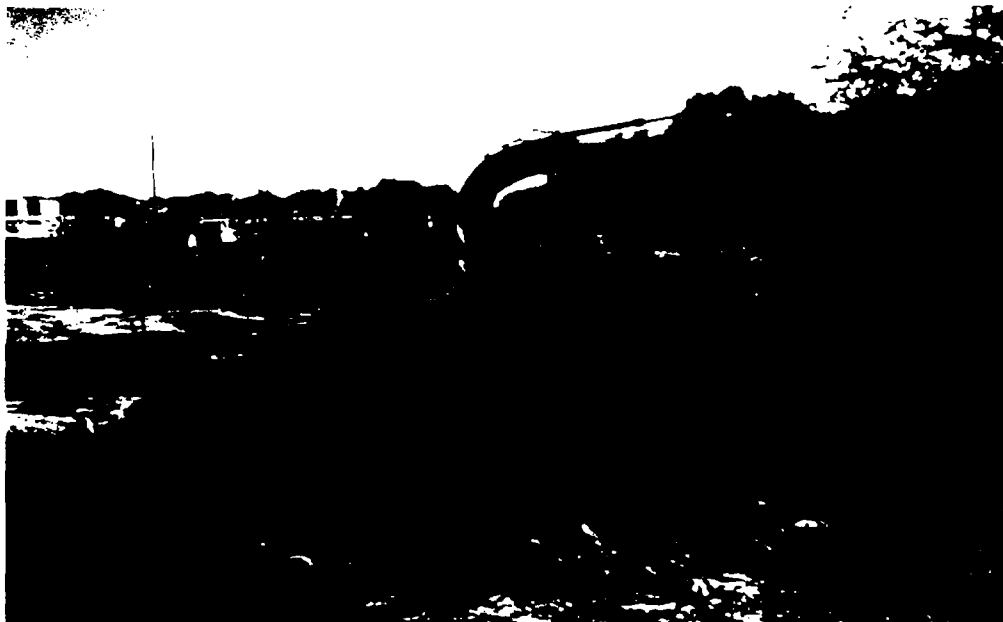
14. August 2001 (Looking North): Rip rap material is placed in swale 3 along Colfax Ave.
